Report

Accident on **28 October 2010**
off **Adélie Land (Antarctica)**
to the **AS 350 B3 Squirrel**
registered **F-GJFJ**
operated by **SAF HELICOPTERES**

BEA

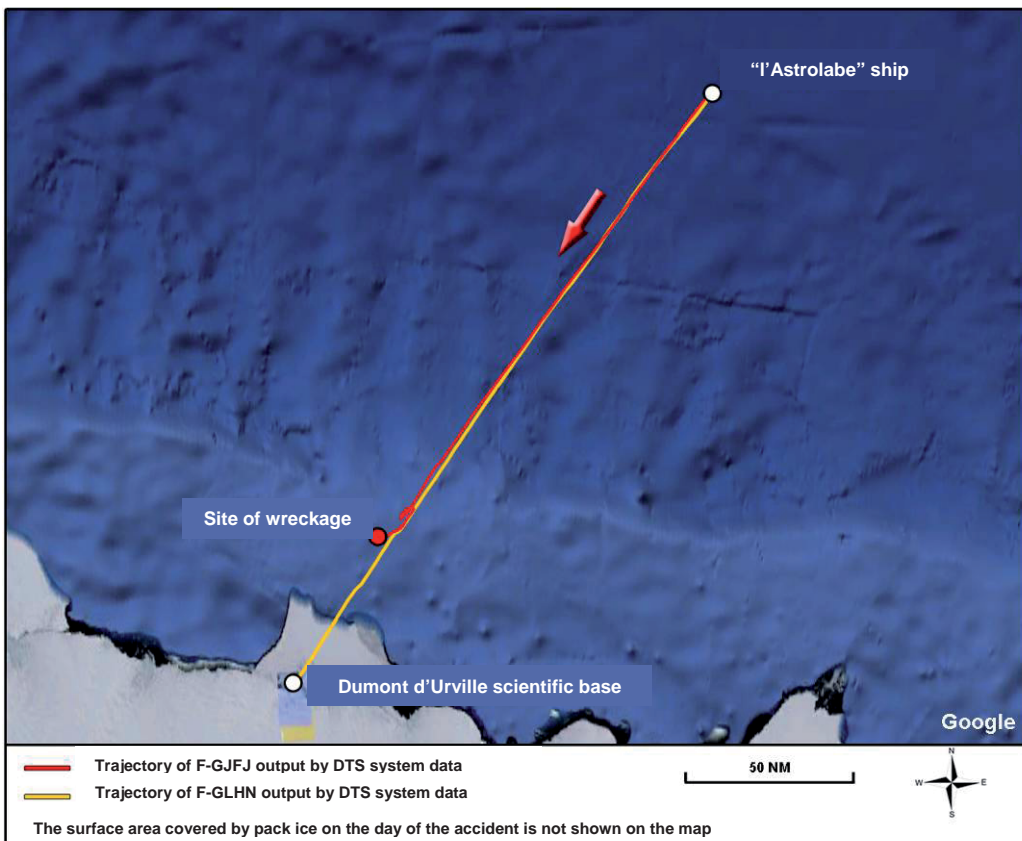
Flight path recorded for helicopters F-GJFJ and F-GLHN

Shortly after 7 h 50, the pilot of F-GJFJ made a 360° turn, during which he descended from 2,500 to about 800 ft. While performing this manoeuvre, he informed the first pilot by radio that he was turning to fly under the cloud layer.

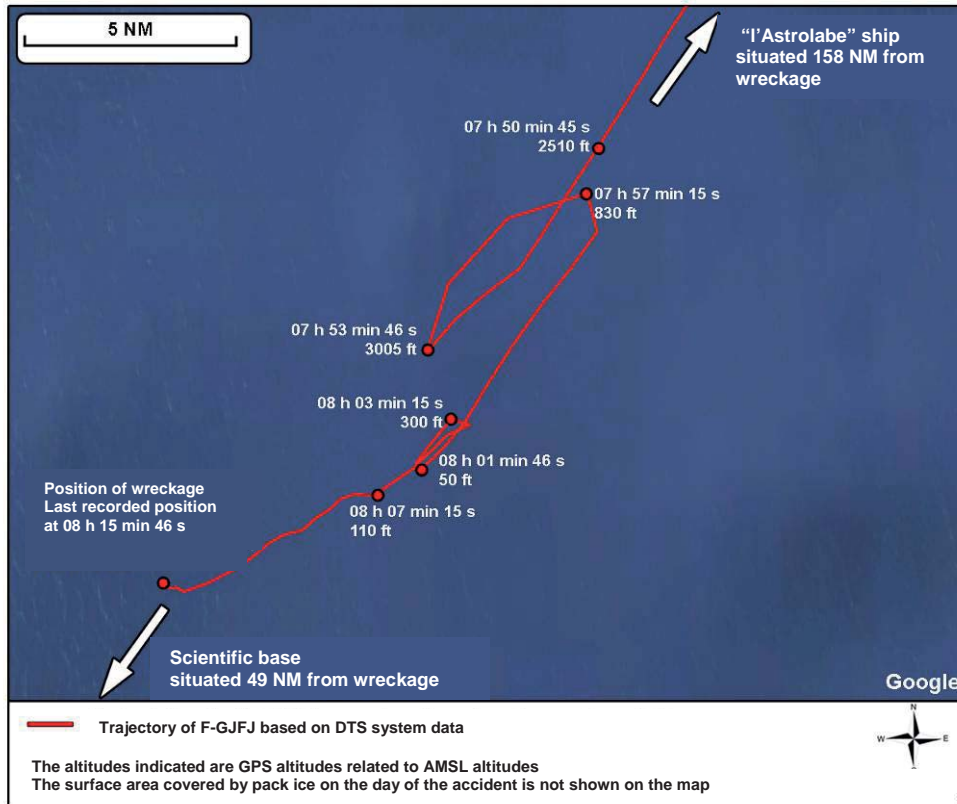
End of F-GJFJ flight path

It was not possible to recover the Brite Saver memory card from the accident site. The data transmitted by satellite to the operator was used to reconstitute the helicopter's flight path prior to the accident (see figure on following page).

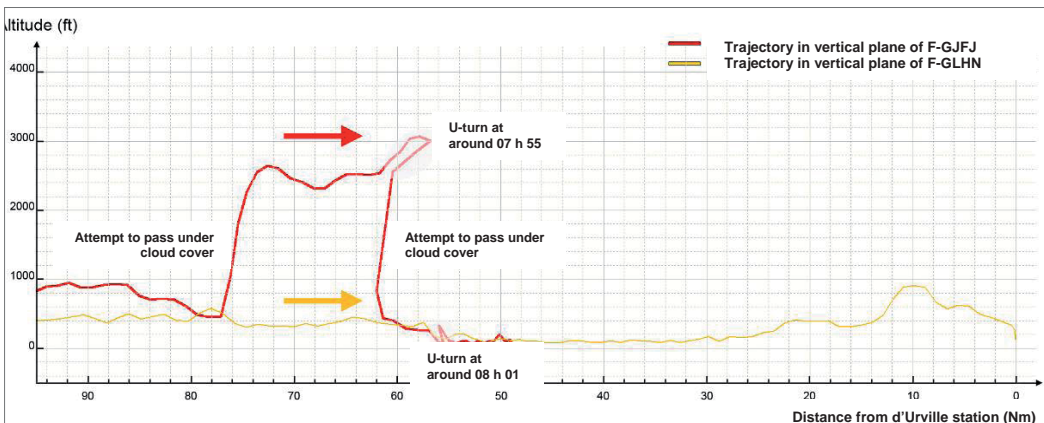
Altitude of the two helicopters as a function of their distance from Dumont d'Urville.

This graph shows the zone in which the first pilot flew under the cloud layer, whereas the second pilot initially decided to fly over the cloud layer before turning back to lose height.

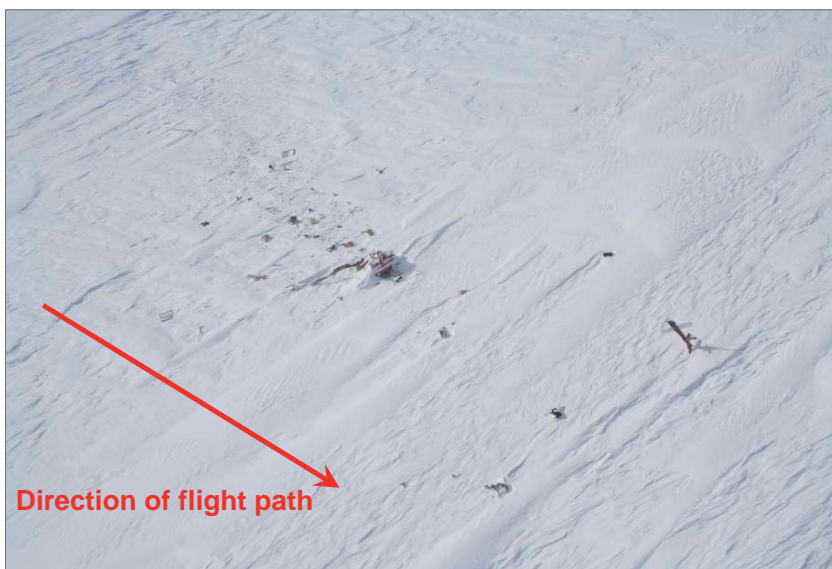
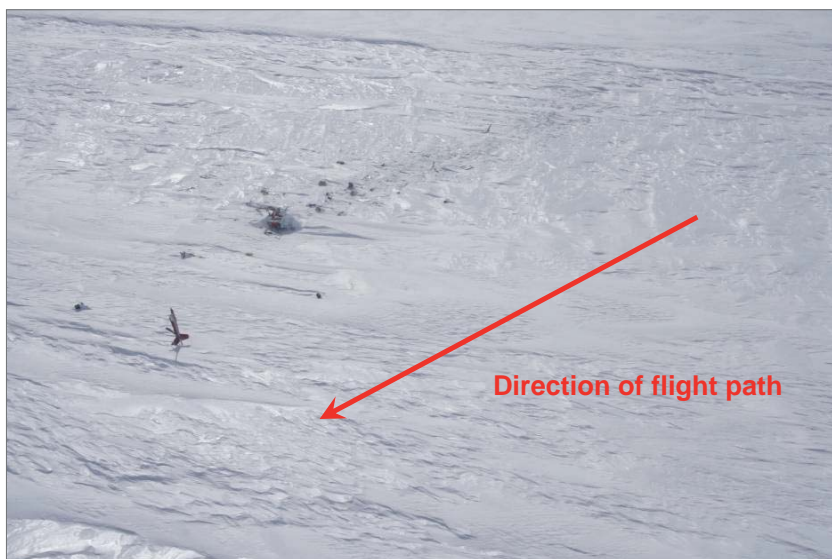
The tail boom, horizontal stabiliser and tail rotor were embedded in the snow in line with the flight path, about 25 metres from the cabin.

The traces of the impact, and the size and distribution of the debris indicate that the helicopter hit the ground with a low vertical speed and a high horizontal speed.

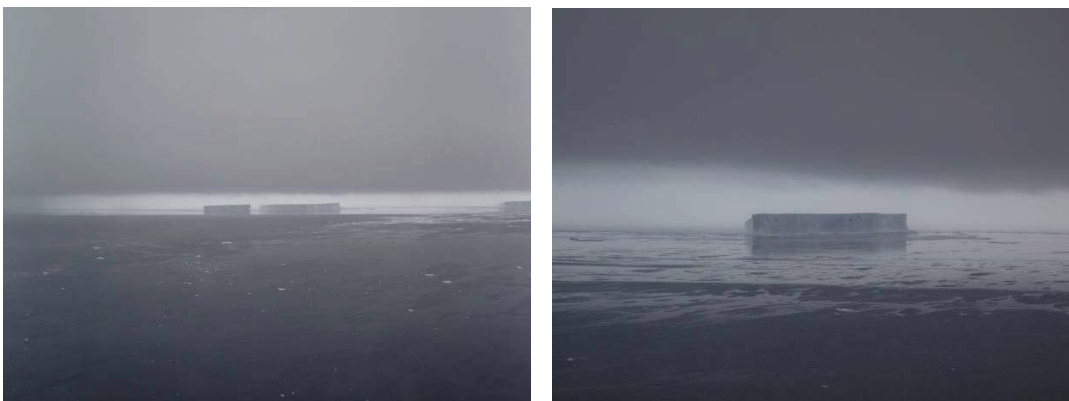
Photo taken more than 1 h 10 after take-off.

In the absence of a radio message indicating a technical problem, it is likely that the meteorological conditions were such that the pilot had to fly in whiteout conditions and as a result was disorientated by losing all his visual references. Under these conditions, and since the pilot was flying at a very low altitude, the helicopter probably hit the pack ice during a descent that the pilot failed to notice due to his preoccupation with searching for visual reference points.
